Investigation of the spatial components of surface runoff pollution in the Jamaica Bay Watershed

Kathy Ammari, Armita Peirovani, Simon Kraatz and Dr.Reza Khanbilvardi NOAA-Cooperative Remote Sensing Science and Technology Center

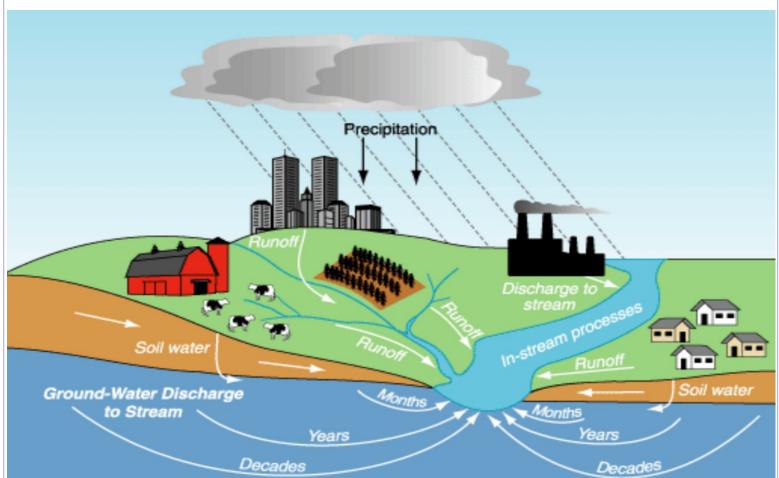
Figure 1. This figure represents different sites of sources of pollutants Source: Philips et al. (USGS FS-091-03)

Figure 1 demonstrates some of the sources of nonpoint source pollutants, which include factories, buildings, and agricultural lands that enter a nearby body of water during a rainfall event. The focus of this study is to investigate pollutants that enter a water body due to surface runoff.

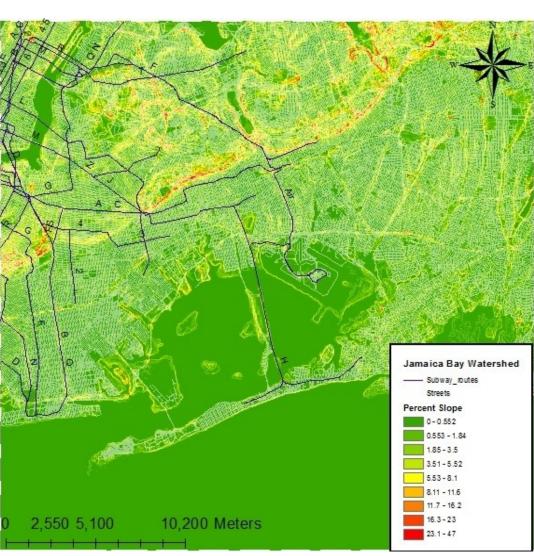
Figure 7. Roads and subway layers overlaid on percent slope for the Jamaica Bay Watershed

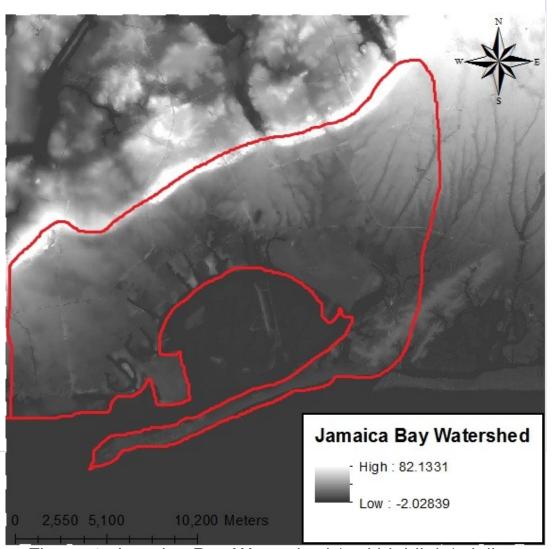
Figure 4. Jamaica Bay Watershed (red highlight) delineated by elevation

A Digital Elevation Model (DEM) was obtained from the USGS National Map Viewer and was cut down to the area of interest by the use of ArcGIS. The National Land Cover Database (NLCD) was downloaded from USGS as well and was cut down to the same area of interest by the use of ArcGIS. A satellite image from the Landsat 8 satellite was downloaded from USGS and cut down to the same study area as the DEM and NLCD maps.

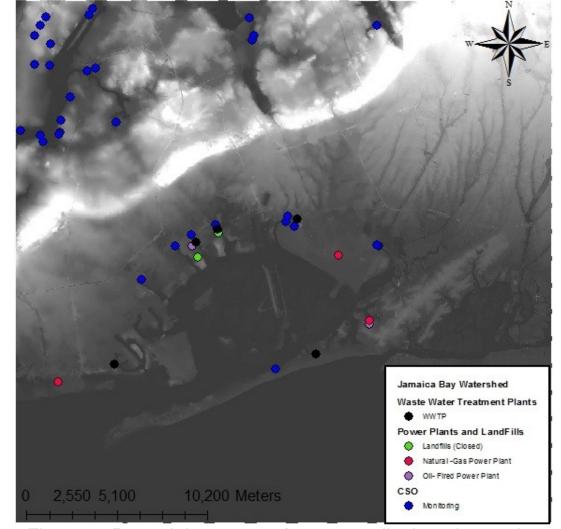
Figure 6. Potential sources of water quality impairment in Jamaica Bay

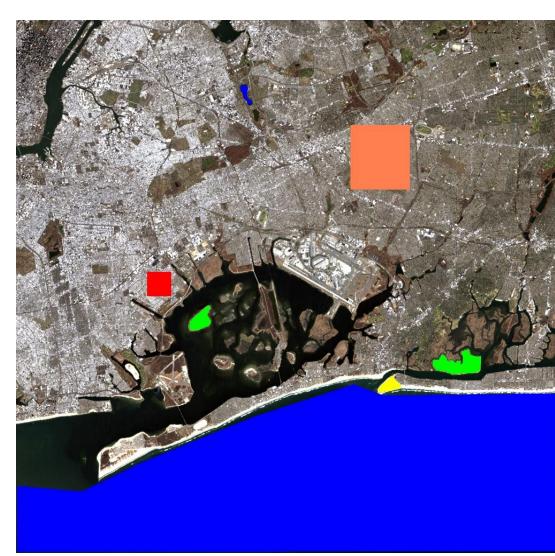
Figure 8. The Region of Interest (ROI) generated are used in multispectral- classification

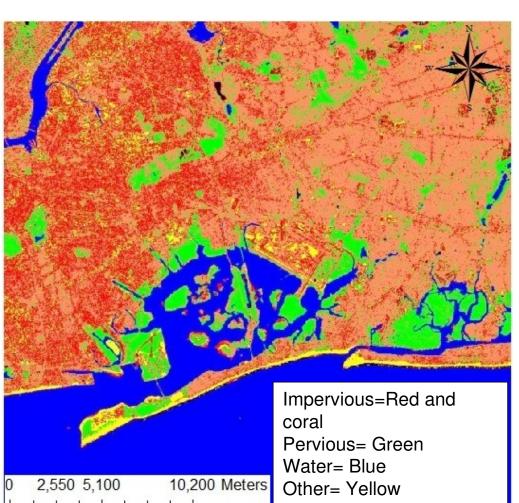
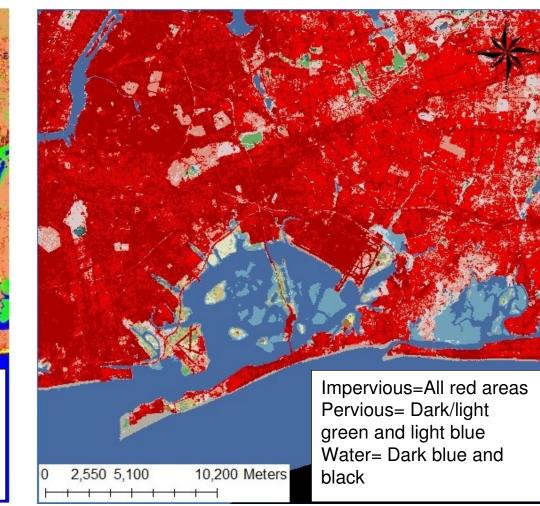
Figure 9. This figure represents the land cover surrounding the study area. The left figure represents land cover from the Landsat 8 satellite image (2014) classified using the supervised Maximum Likelihood algorithm on ENVI classic and the right image represents the land cover from NLCD (2011)

Table 1. Comparison of Landsat 8 (2014) and NLCD (2011) land cover statistics

Class (est.)	Landsat 8	NLCD
Impervious	50.5	62.7
Pervious	9.4	0.65
Water	34.5	36.6
Other ¹	5.2	0
